Installation instructions

For set # 3.3190
1999-04 CHEVY / GMC
K1500 SILVERADO / SIERRA 4WD

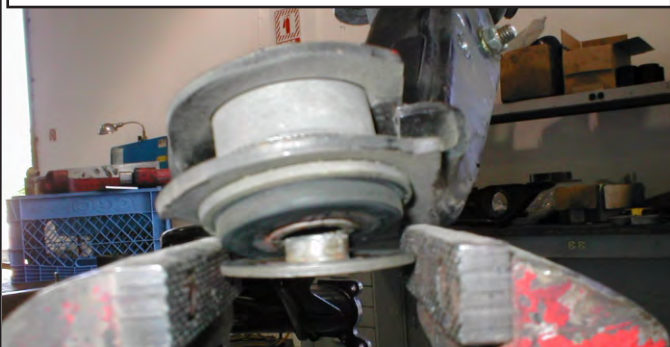
DO NOT REMOVE OUTER METAL SHELL FROM UPPER CONTROL ARM.

To remove cap washers on upper control arm, clamp cap washer in vice and wiggle arm back and forth. Inner sleeve is not bonded, use spray lube to help press it out.

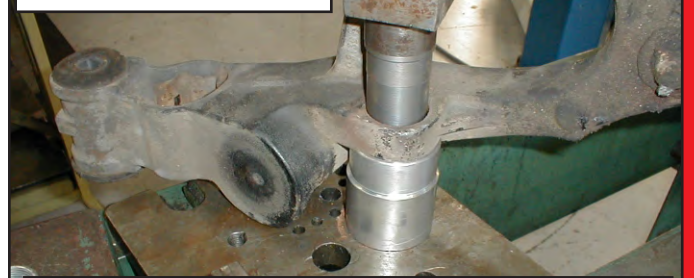
LOWER CONTROL ARM SHOCK POSITION

The outer metal shell must be pressed out before installing the new shock bushings. I.D. of control arm is $\varnothing 1.610$ ". Press out shell with something smaller than $\varnothing 1.610$ ".

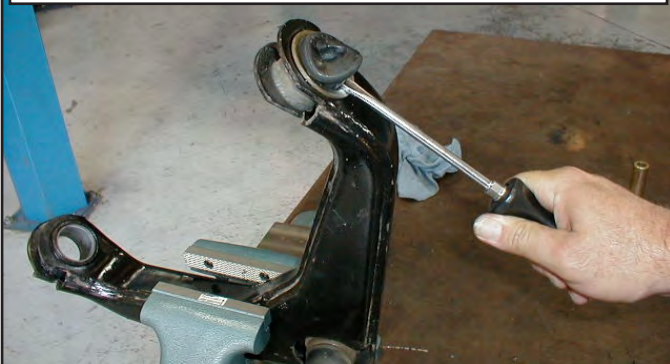
After inner sleeve has been removed, pry out old bushing. Make sure inside surfaces are free of all old bushing material and sharp edges. Coat urethane bushing, sleeve and shell I.D. with supplied grease. (all surfaces of bushings that contact metal). Inner sleeve and cap washer must be reused.

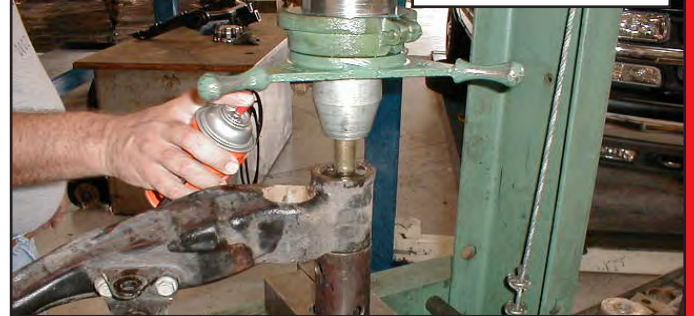
Lower control arm

There is no outer metal shell to press out. The rubber bushings are bonded to the inner sleeve, but not the control arm. Press the bushing/sleeve out as a unit. Use spray lube to help remove the old rubber bushings from the lower control arms.
